A Review of the 2012 Reynosa Gas Plant Explosion

An ioMosaic White Paper

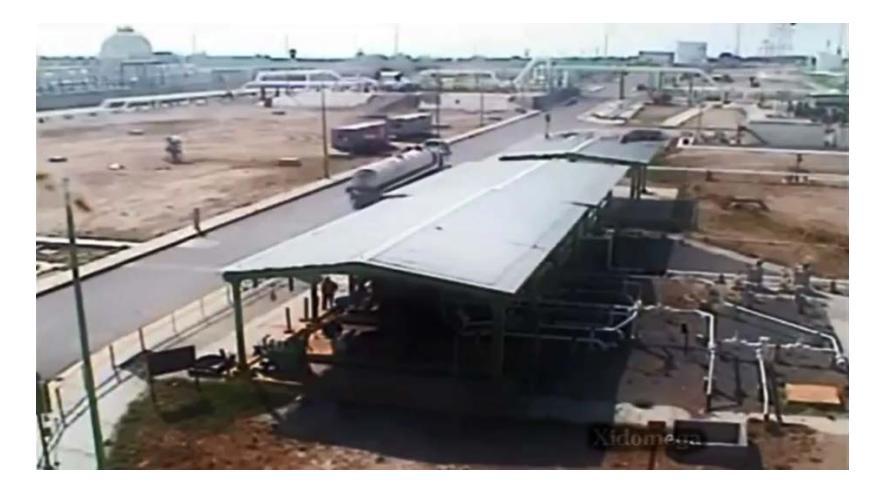
Figure 1 – Still Footage From The Video Clip

On September 18, 2012, a major fire and explosion ripped through a gas plant in Reynosa, Mexico resulting in 31 fatalities and many injuries. The incident was caught on Closed Circuit Television (CCTV) and has been viewed millions of times on social media sites such as YouTube. The video clip is particularly useful to process safety practitioners as it demonstrates the various hazardous outcomes that can result from one individual loss of containment event. In the case of this incident, it is possible to see the initial pressure wave, followed by turbulent momentum jet dispersion, then a flash fire and jet fire, as well as shrapnel projectiles.

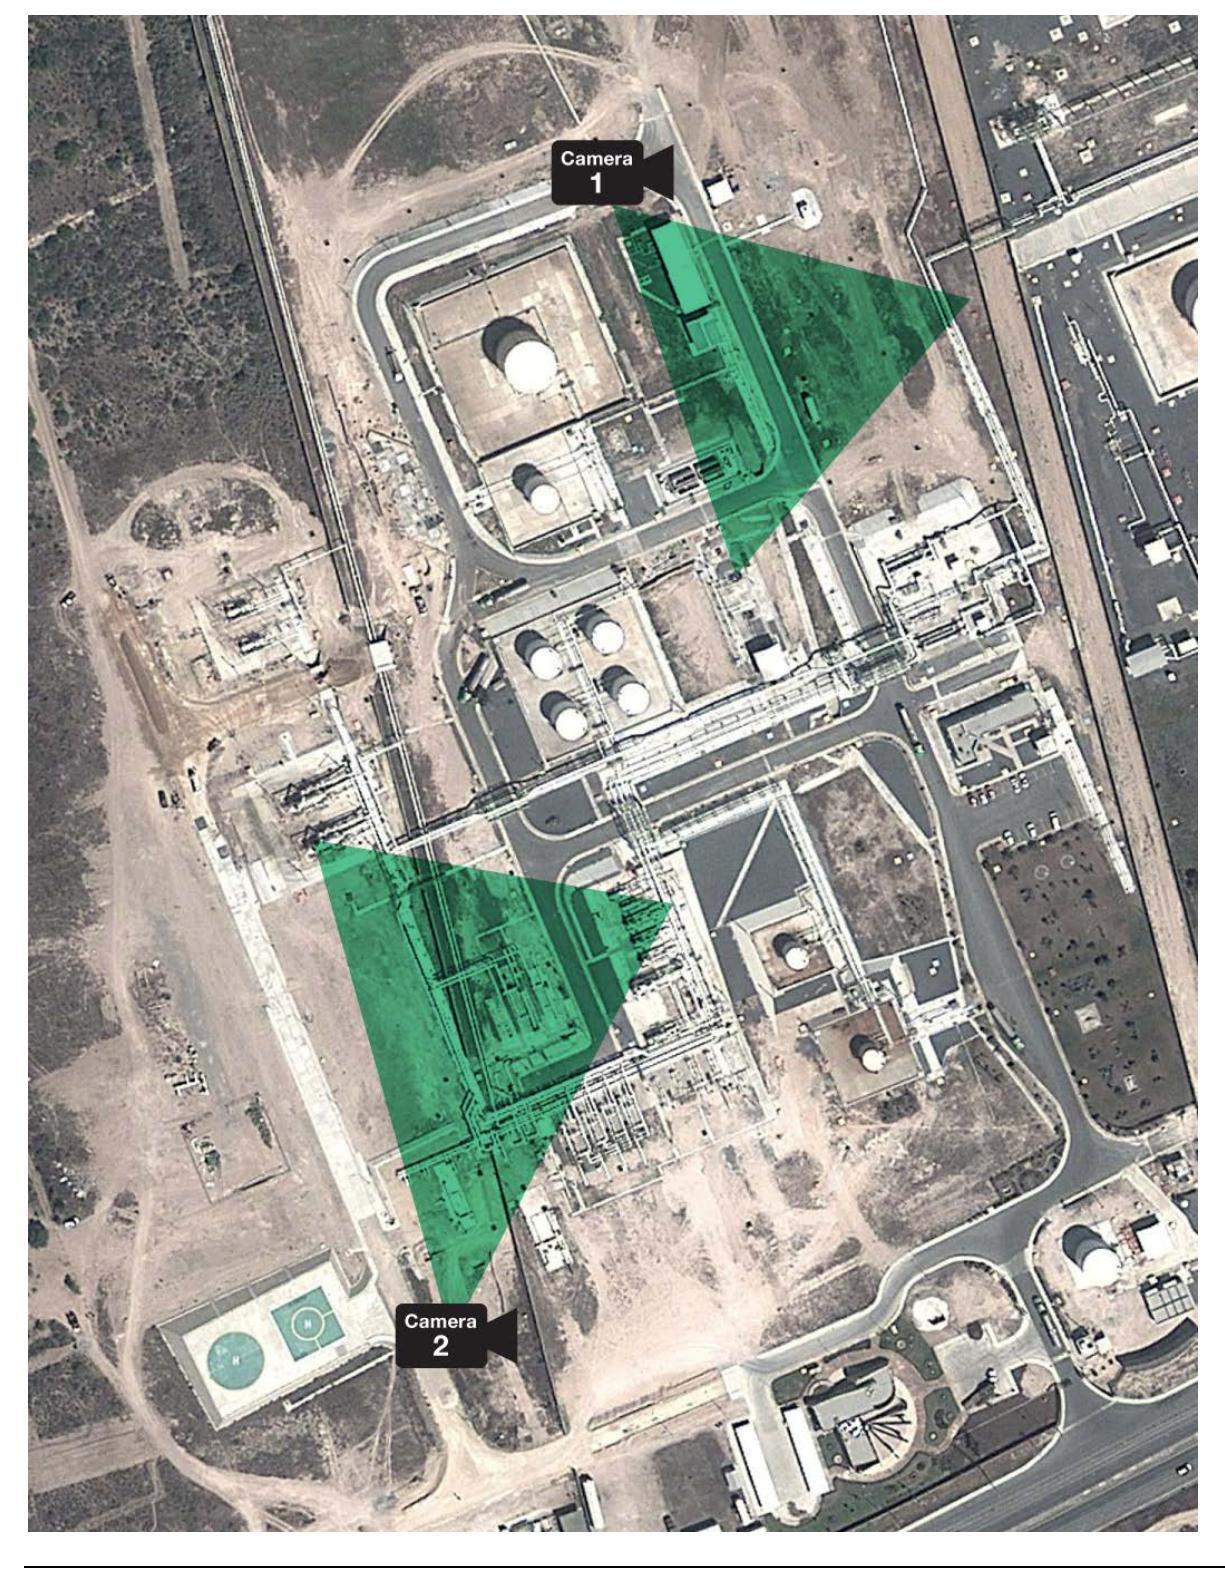
Figure 3 – Aerial View of Affected Area, with Location and Direction of Cameras Which Recorded the Incident.

Figure 2 shows the facility main entrance, while Figure 3 shows an aerial view of the affected area, including the locations of the cameras which recorded the incident (labelled here as Camera 1 and Camera 2).

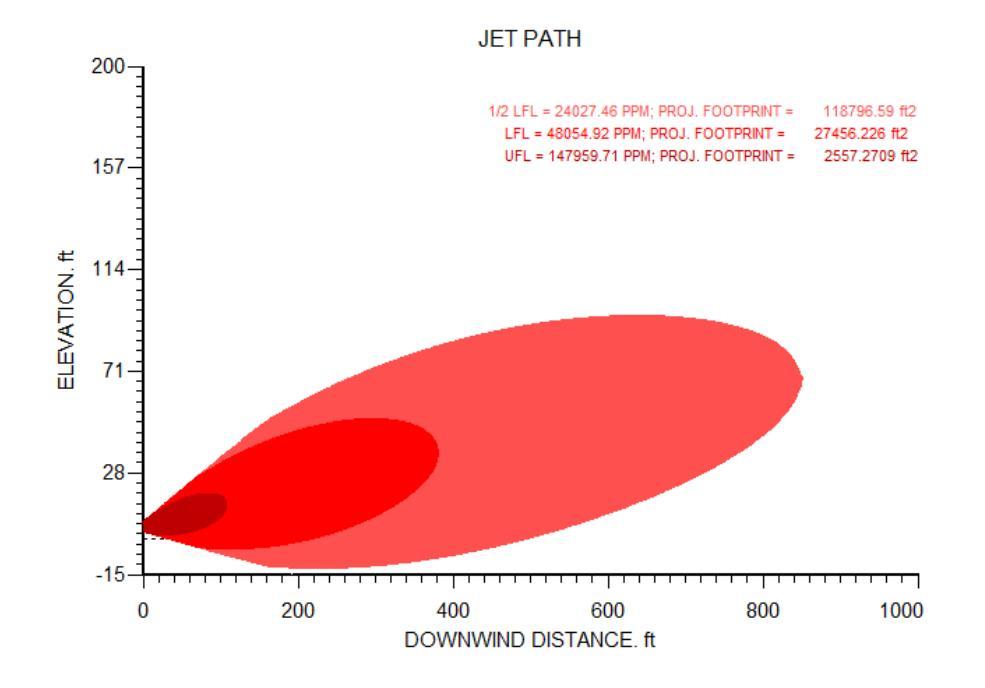
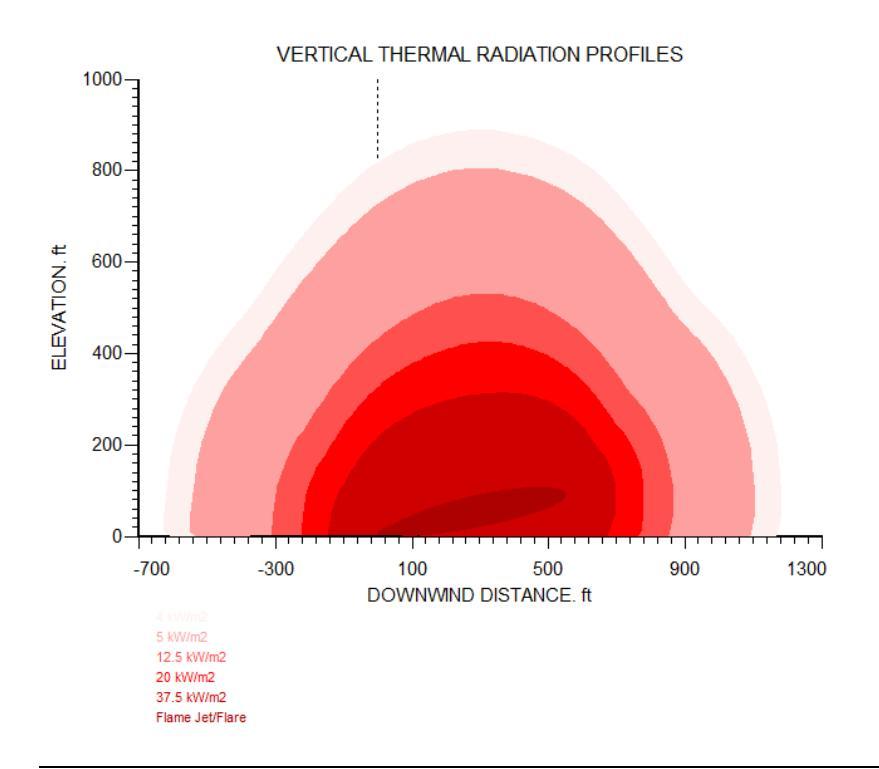
Figure 6 – Thermal Radiation Effects (Side View)

The results modeled here determined a release rate of approximately 900 kg/s; which resulted in a jet fire of over 500 feet and lower flammable limit of almost 400 feet. These results are very consistent with the jet fire results seen in the video clip.

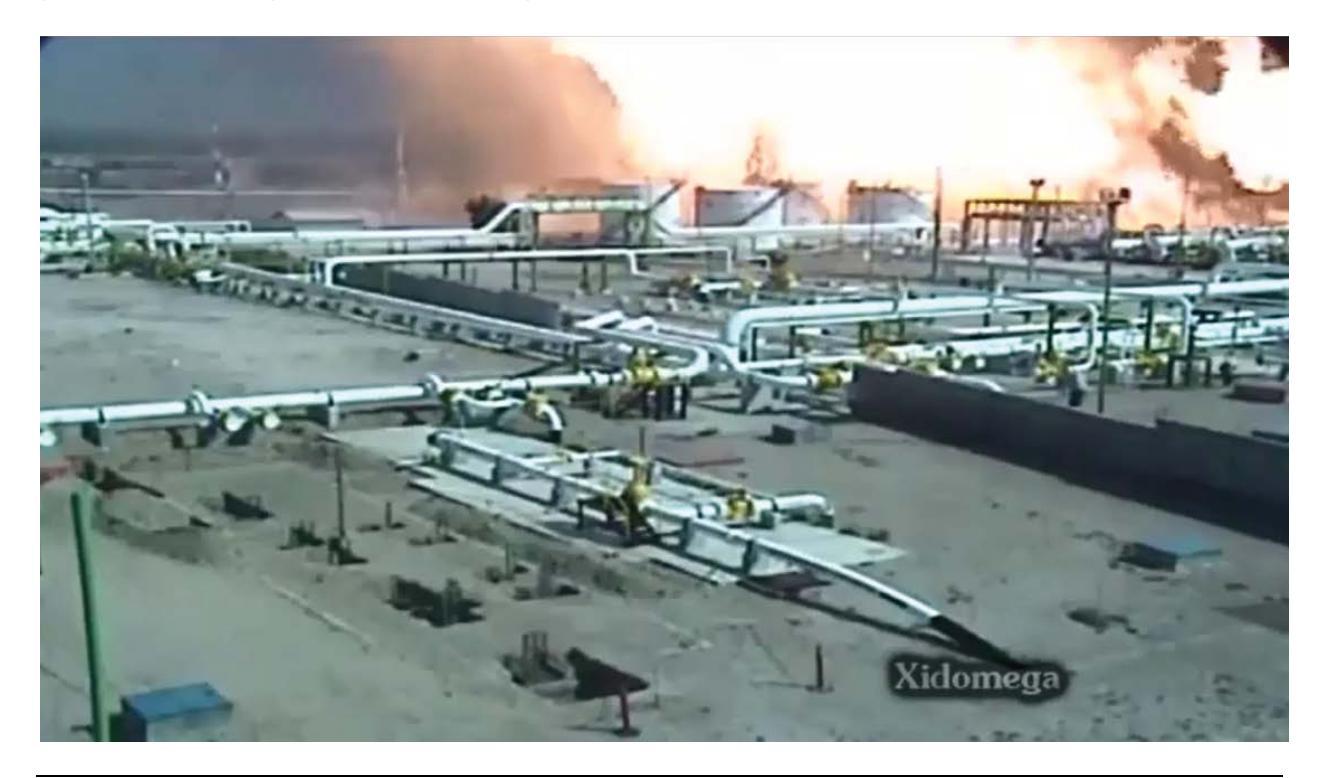
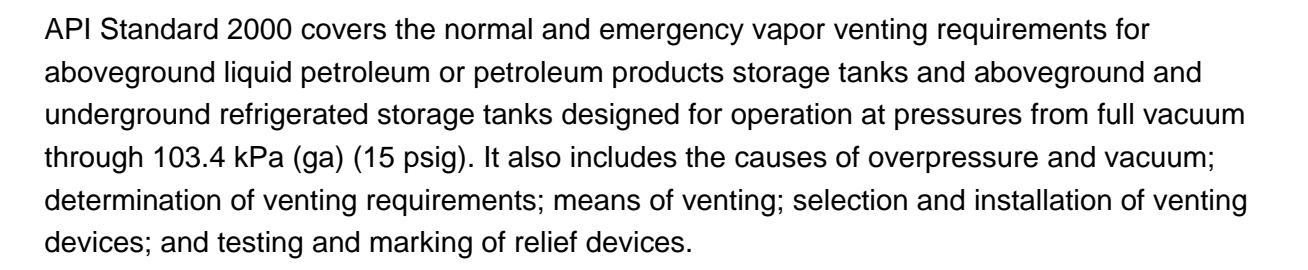
Figure 8 – Venting See Coming From Storage Tanks

In the video clip (and shown in Figure 8), it is possible to see vapors venting from the storage tanks which are being impinged upon by the major jet fire. Atmospheric storage tanks are protected for overpressure and underpressure scenarios as described in API Standard 2000.

While the conservation vents protecting these tanks are seen to be venting, they would not be intended to protect against such a severe event as jet fire impingement, therefore the tanks would eventually be expected to fail as the tank metal wall temperatures increased.

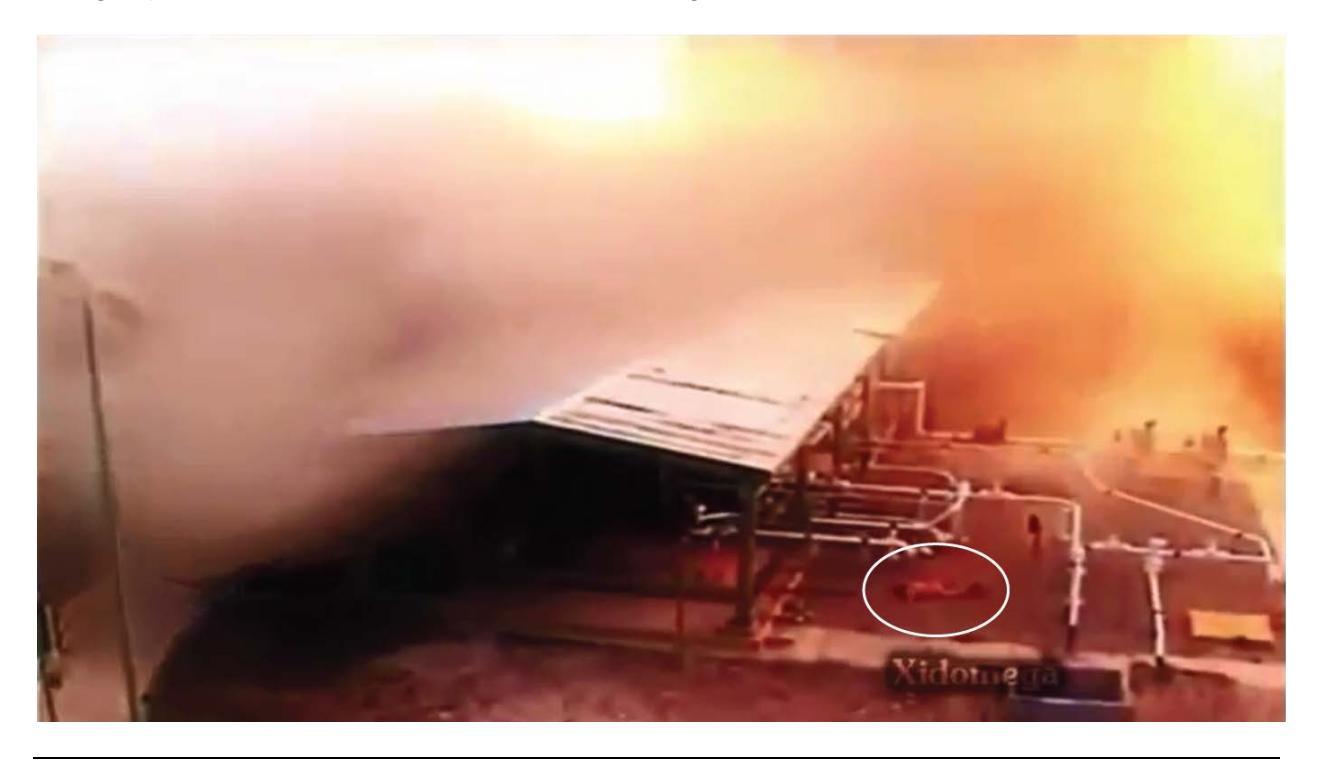
Figure 9 – Affected Person

In the video clip, a person can be seen in the foreground having had his clothes burned off after being exposed to the flash fire. This is shown in Figure 9.

Flame Retardant Clothing (FRC) is a well-known passive safeguard, commonly used in many facilities, and stipulated by organizations such as API, OSHA and NFPA. FRC is personal protective equipment (PPE), which is the last line of defense after engineering controls and administrative controls have failed. FRC are designed to protect against a flash fire that only

When considering this information, the wearing of FRC is common sense in any facility handling flammable materials, even when the operating company does not mandate it. An ounce of prevention is worth a pound of cure!
