A Review of the 2012 Reynosa Gas Plant Explosion

An ioMosaic White Paper

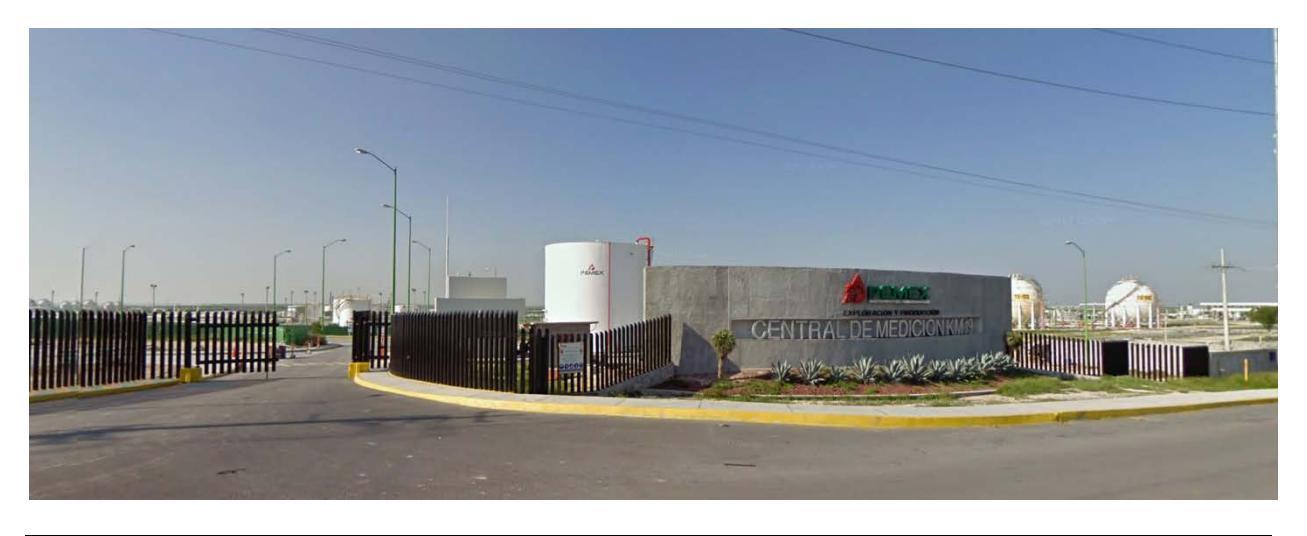
Figure 2 – Facility Entrance

Figure 2 shows the facility main entrance, while Figure 3 shows an aerial view of the affected area, including the locations of the cameras which recorded the incident (labelled here as Camera 1 and Camera 2).
